GENERAL NOTES:

SPAN AND PIER NOTES:

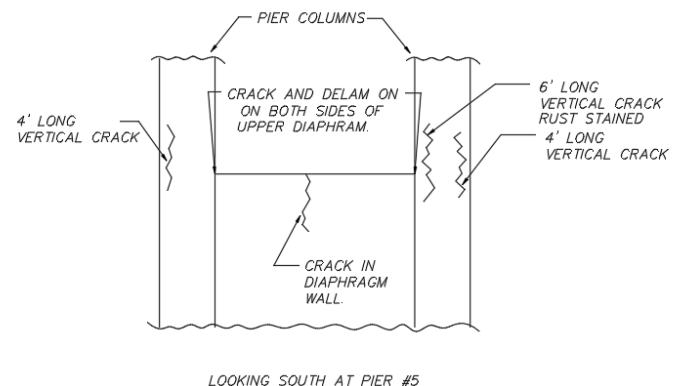
Pier wall (lower) has a vertical crack at the top, horizontal crack on the south face, and multiple vertical cracks in the columns on the

north face (see diagram).

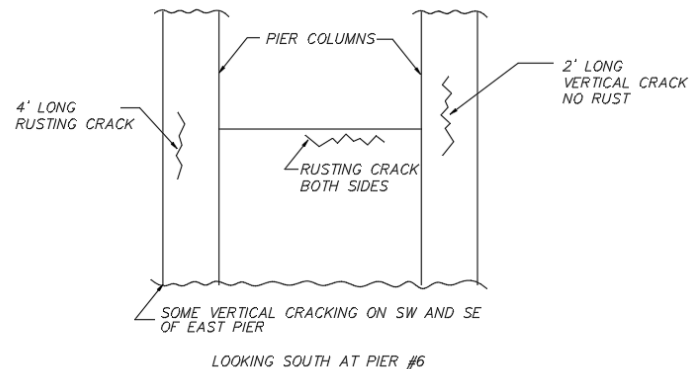
Pier wall (lower) and columns have vertical/horizontal cracks (see diagram).

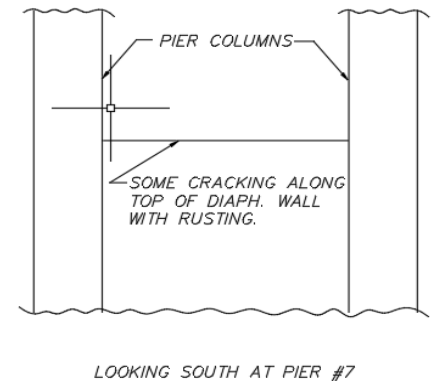
Pier wall (lower) has some narrow/open cracking along the top (see diagram).

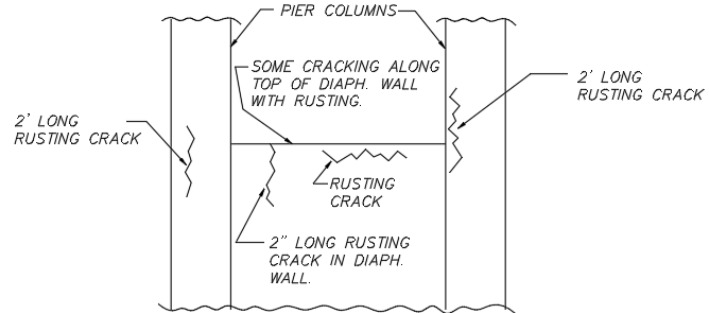
LOOKING SOUTH AT PIER #8

Pier wall (lower) and columns have vertical/horizontal rusty cracks (see detail).

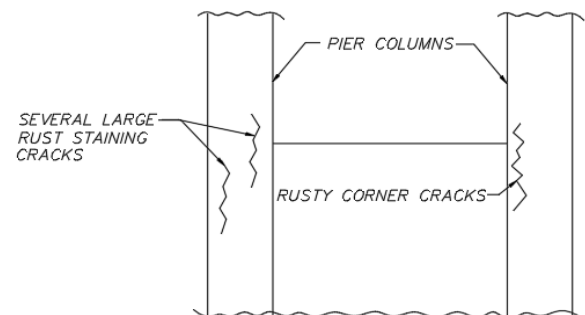
LOOKING SOUTH AT PIER #9

Pier wall (lower) and columns have several rusty vertical/horizontal cracks (see detail).

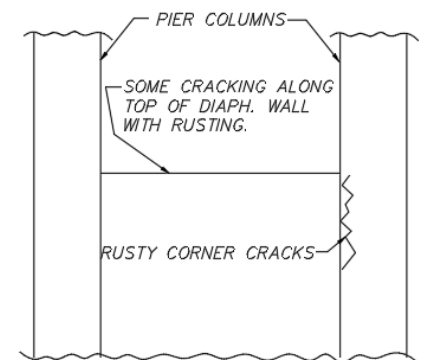
LOOKING NORTH AT PIER #13

Pier wall (lower) and columns have short rusty leaching cracks (see diagram).

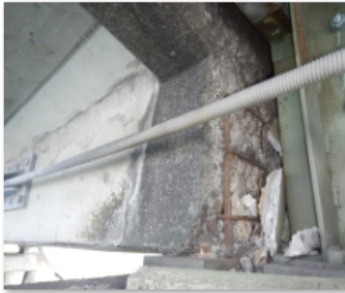
26211-A Girder 17A end spalling with exp rebar (4).JPG

Pier 17: Girder 17A south-face (end) at the bearing has broken up and spalled up to 4" from the end of the girder and has exposed rusty rebar and anchor bolts which were cast into the girder during initial construction. Concrete at the bearing plate is beginning to break up. Bearing area is reduced.

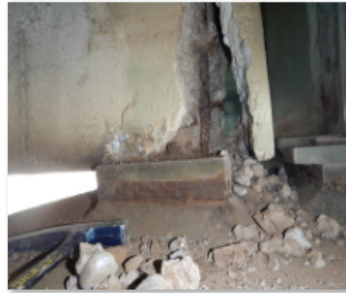
26211-A Girder 17B end spalling with exp rebar (3).JPG

Girder 17B south-face (end) at the bearing has broken up and spalled up to 6" from the end of the girder and has exposed rusty rebar and anchor bolts which were cast into the girder during initial construction. Concrete at the bearing plate is beginning to break up. Bearing area is reduced.

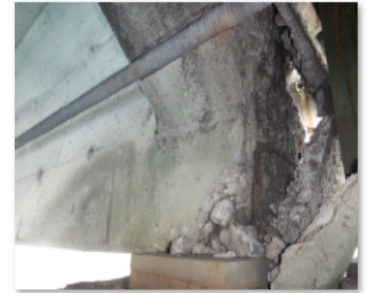
26211-A Girder 17C end spalling with exp rebar (2).JPG

Girder 17C south-face (end) at the bearing has broken up and spalled up to 4" from the end of the girder and has exposed rusty rebar and anchor bolts which were cast into the girder during initial construction. Concrete at the bearing plate is beginning to break up. Bearing area is reduced.

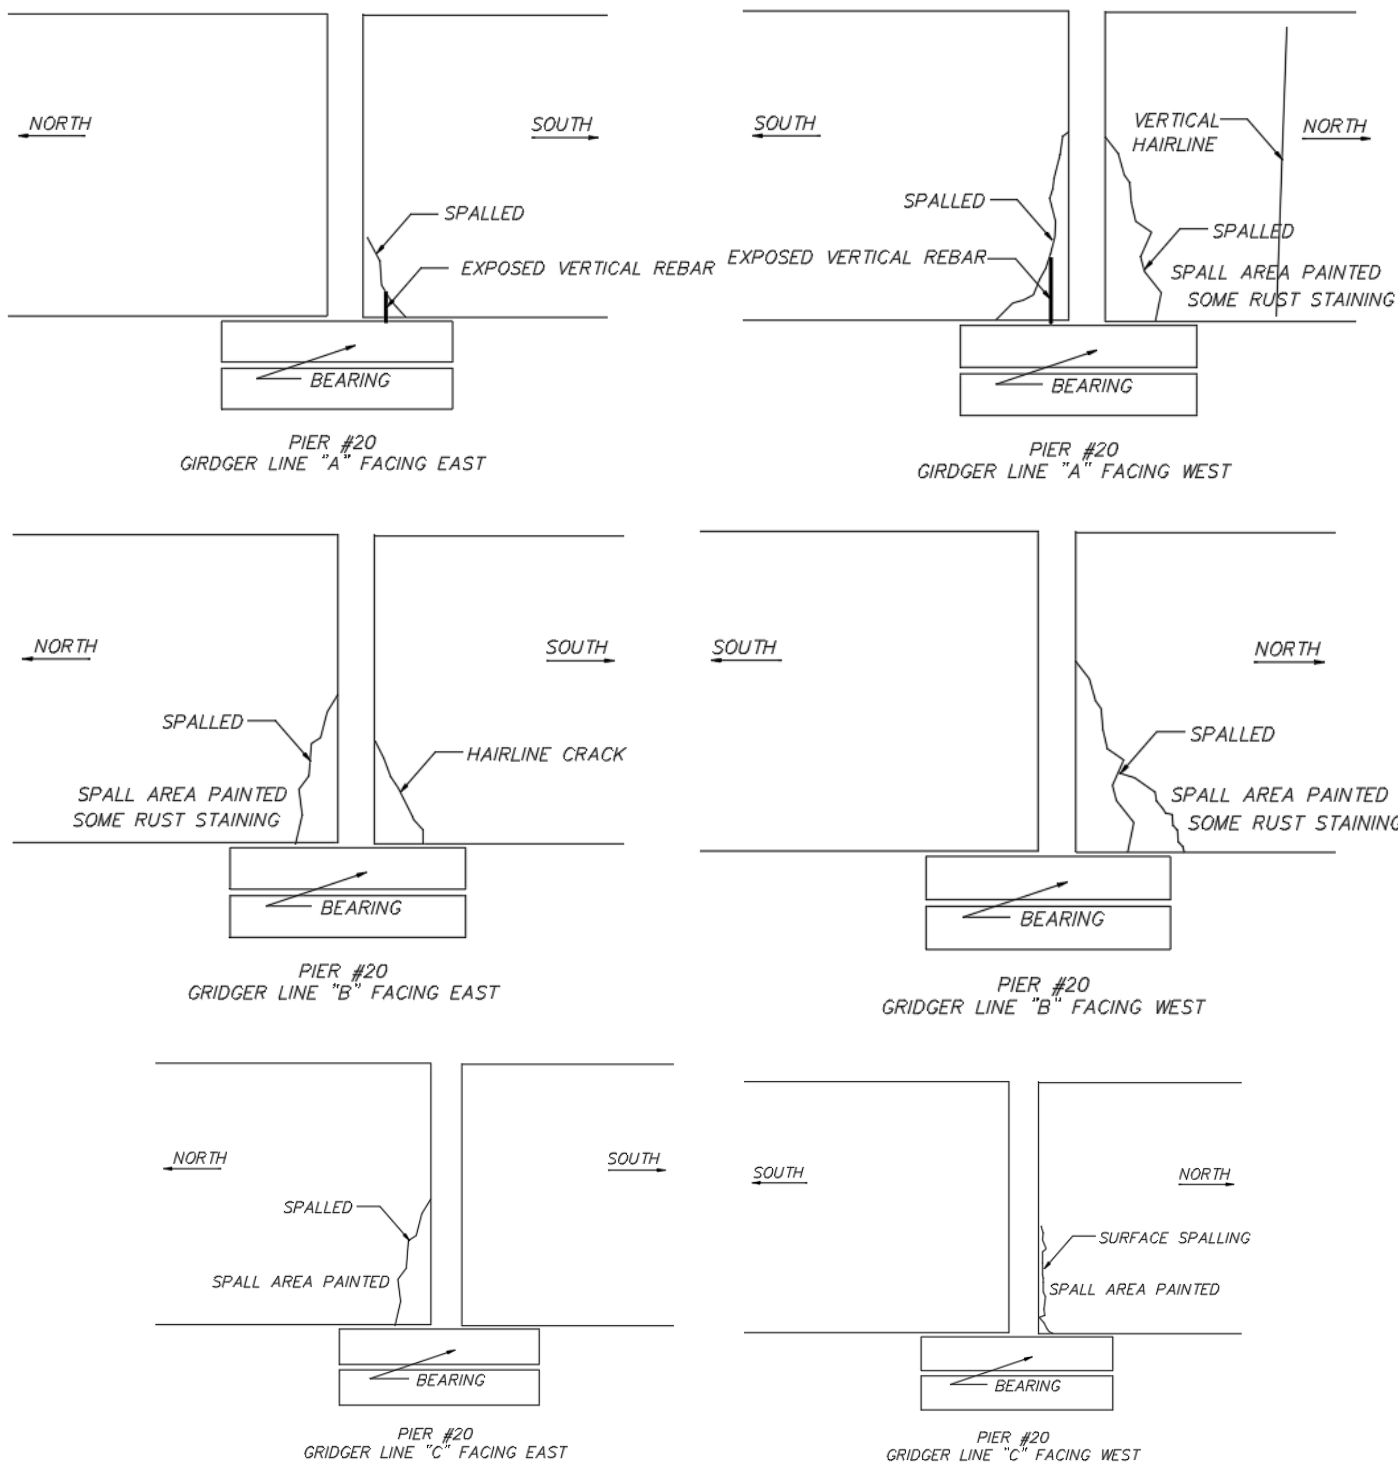
Pier 20: Girders have diagonal spalls at the bearing with exposed rebar.

Girders ends at Pier 20 have been chipped, cleaned and painted (see diagrams).
