PIERCE COUNTY THREAT AND HAZARD IDENTIFICATION WORKSHOP:

MUD MOUNTAIN AND HOWARD A. HANSON DAMS

Richard E. Smith, PG
Dam Safety Program Manager
Northwestern Division/Seattle District
Date: 2 May 2019

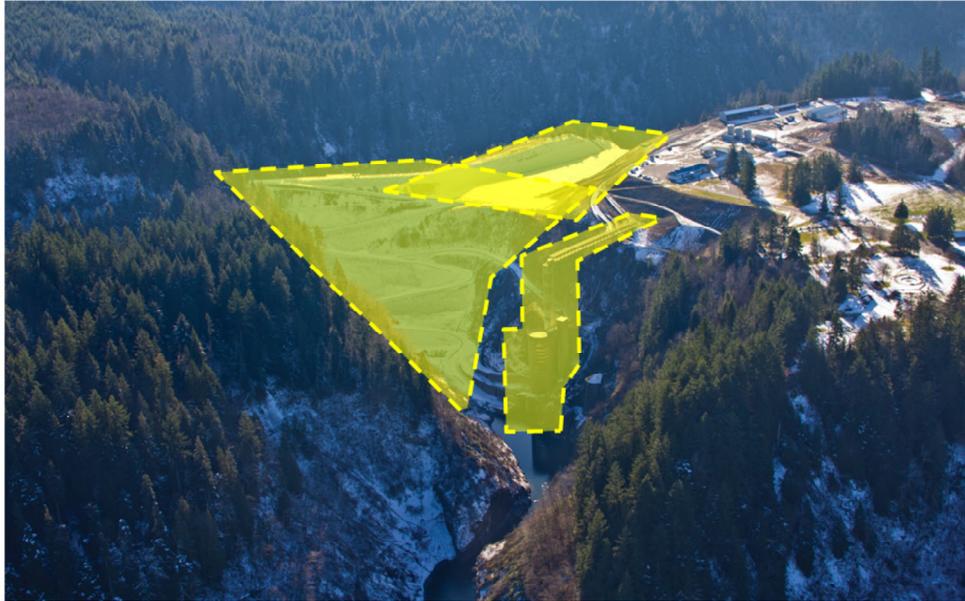
MUD MOUNTAIN DAM - FEATURES

Looking at the upstream side of the dam, we have the 432 foot high earthen embankment.

We have our outlet works structure. This is what we use to regulate and pass the river under most flow conditions. There are two tunnels and three gate openings inside the tower. Two gates control the 23 foot diameter tunnel, and one controls the 9 foot tunnel.

We also have a spillway to pass flows in extreme flood events. This spillway has never been used to pass flow.

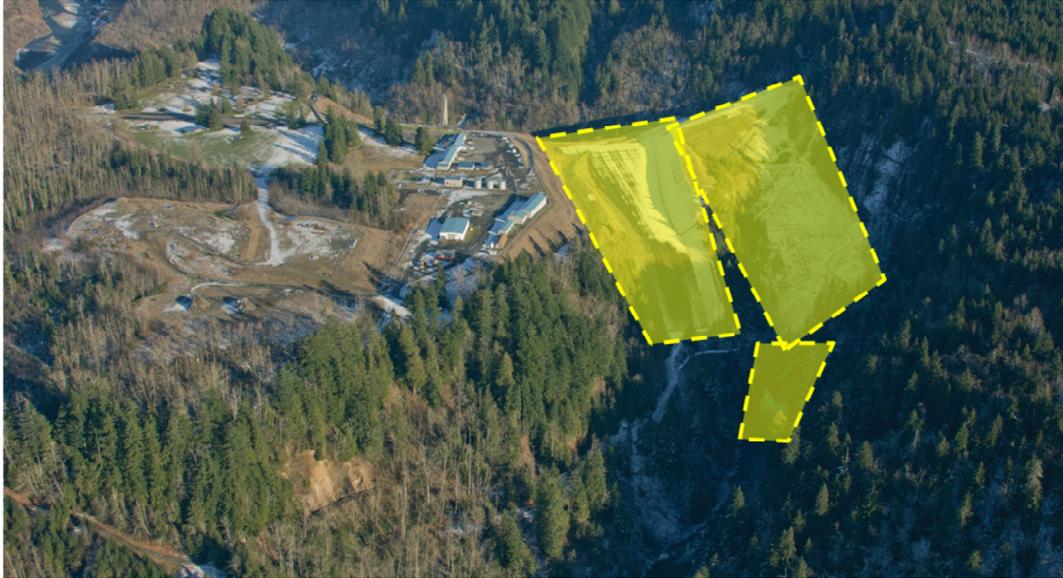
MUD MOUNTAIN DAM - FEATURES

On this view from the downstream side, we have the embankment again for reference and the spillway.

Down in a very narrow canyon are located the exit portals for our outlet works tunnels.

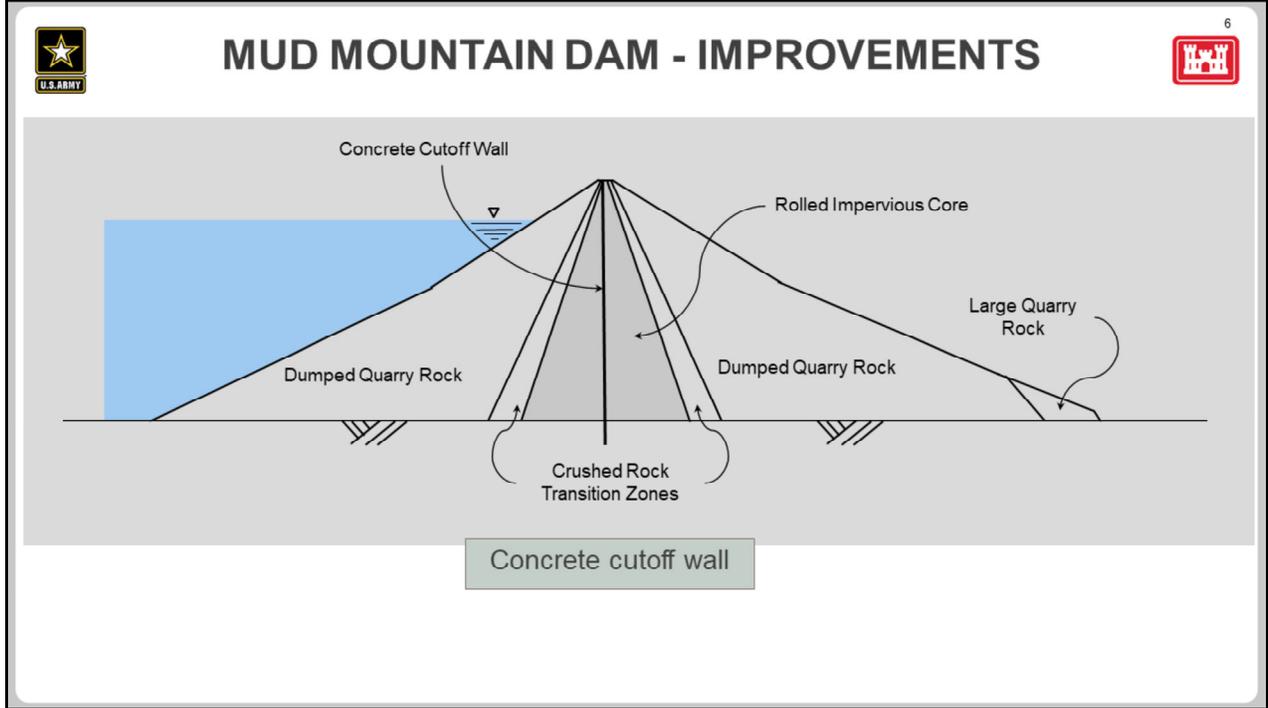
During the 1980’s engineers monitoring the dam’s instrumentation became concerned that the central impervious core (shown in darker gray) of the dam was slowly eroding during flood storage events. Subsequent tests and investigations confirmed that loose zones, voids and cracks were present within the dam’s impermeable core and if left untreated had the potential to lead to dam failure. To mitigate these concerns, USACE designed a concrete cutoff wall to penetrate from the top of the dam, 432 feet through the dam and 15 feet into bedrock. The cutoff wall lessens seepage and prevents the development of a continuous erosion path through the dam.

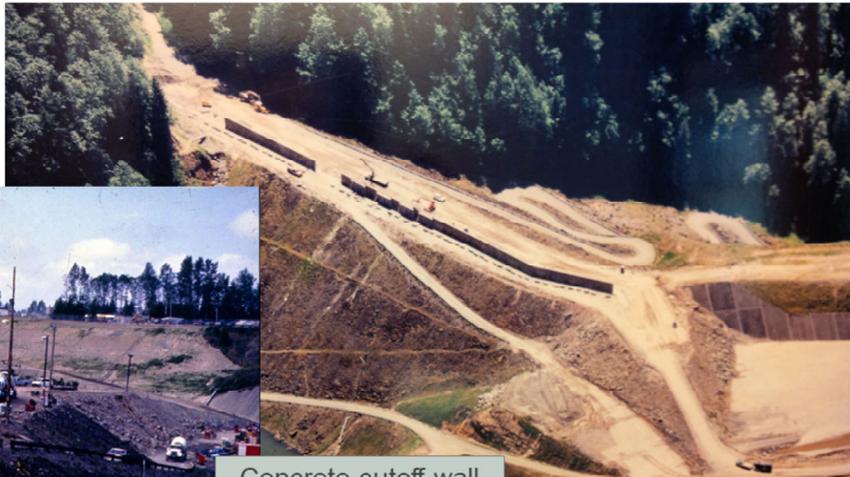
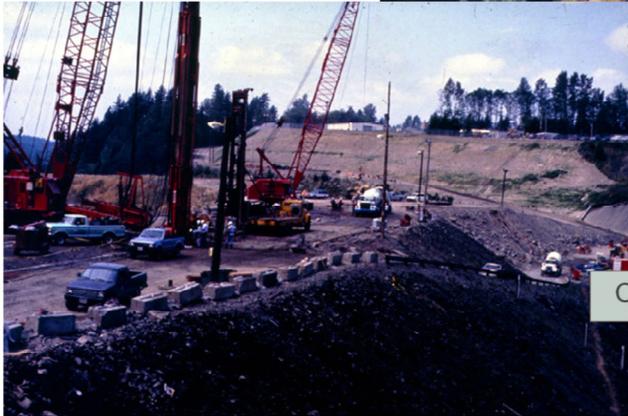
Concrete cutoff wall

A contract was awarded to Soletanche Inc. (French company) who installed the cutoff wall using equipment called a hydrofraise in 1989 and 1990. The wall thickness varies from one foot thick to 40-inches thick depending on depth and location within the embankment. At the time of construction, it was the deepest such cutoff wall in any dam on earth.

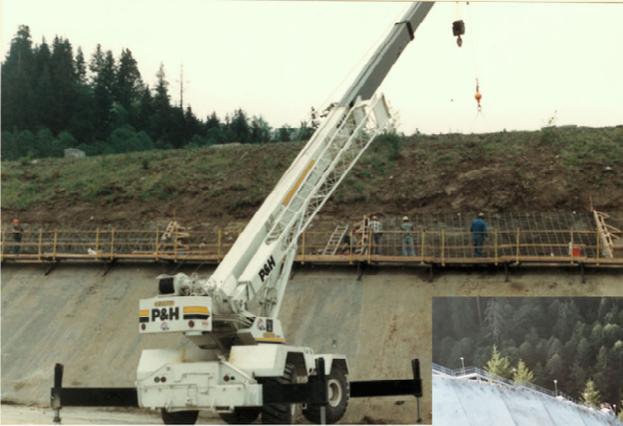
Raising of spillway sidewalls

The spillway sidewalls were raised to accommodate the PMF without overtopping the sidewalls and eroding the adjacent material.

In the 1980s, the probable maximum flood (the most severe rain event that is considered possible for this basin) was revised. The dam was found to both have an inadequately sized spillway to pass the PMF and the dam was not tall enough to prevent overtopping during this extreme event.

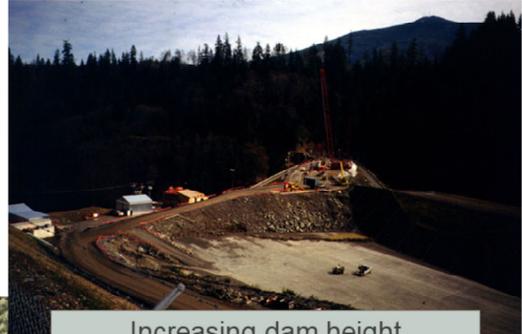
Increasing dam height

During construction of the concrete cutoff wall, the top 10 feet of the dam were removed to provide a large enough working pad to accommodate the hydrofracture machinery. The dam was subsequently raised seven additional feet beyond its original height to accommodate the storage pool for the revised PMF.

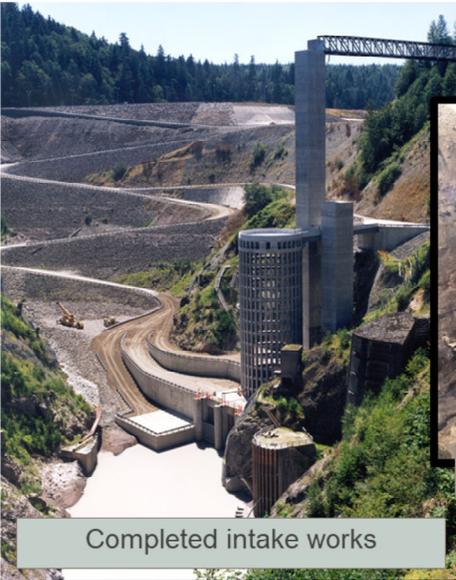
Completed intake works

An earthquake study and reservoir debris evaluation, both completed in 1984, indicated that the 9-foot and 23-foot-diameter tunnel intake towers were likely to fail either during the Maximum Credible Earthquake (MCE) or the Project Design Flood, blocking the tunnels and causing the pool to rise with no means to subsequently evacuate the impounded water. To solve this problem, the two existing intake towers were replaced by a single intake tower capable of remaining operational during an earthquake or flood. The intake tower replacement was completed in 1995.

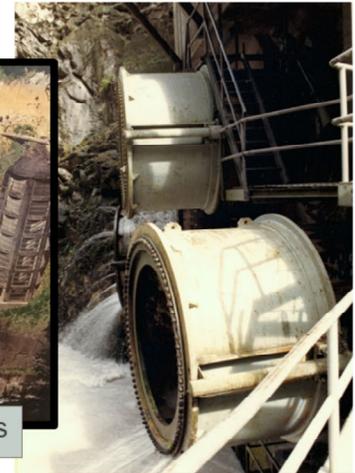
Howell-Bunger Valves
on 23-foot tunnel

As part of this work, the original Howell –Bunger valve system that controlled flow through the 23-foot tunnel at the downstream end was replaced by an upstream radial gate.

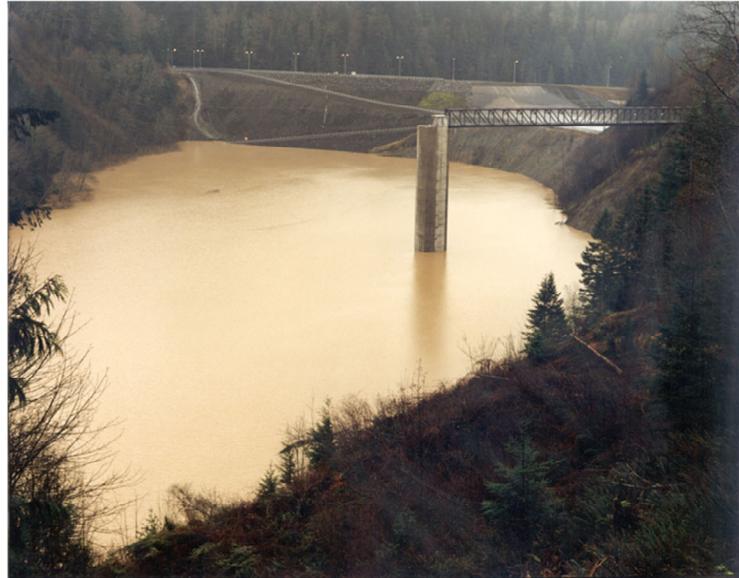
Pool of Record
– February 1996
– Elevation 1,199.5 feet
NAVD 88
– 19 feet below spillway
crest

The dam has never experienced its full pool. The primary purpose of Mud Mountain Dam is to provide a storage basin in which excessive runoff from the White River drainage area can be temporarily retained, thus preventing damaging floods in the lower Puyallup Valley. During winter months, when the flood threat is at a maximum, the reservoir is kept essentially empty. Normal river flow at this time is passed through the 9-foot outlet tunnel in the dam's right abutment. When the river flow exceeds the 9-foot tunnel capacity, flow is passed through the 23-foot tunnel and regulated to limit releases for downstream flood risk management. Currently the two flood control objectives are to maintain releases as low as possible to protect flood prone areas in the City of Pacific, and to maintain a total flow less than 50,000 cfs at the city of Puyallup, below the confluence of the Puyallup and White Rivers. Floodwater in excess of these releases is impounded in the reservoir. After the peak of the storm, these releases are maintained to empty the reservoir as fast as possible to provide storage space for subsequent floods.

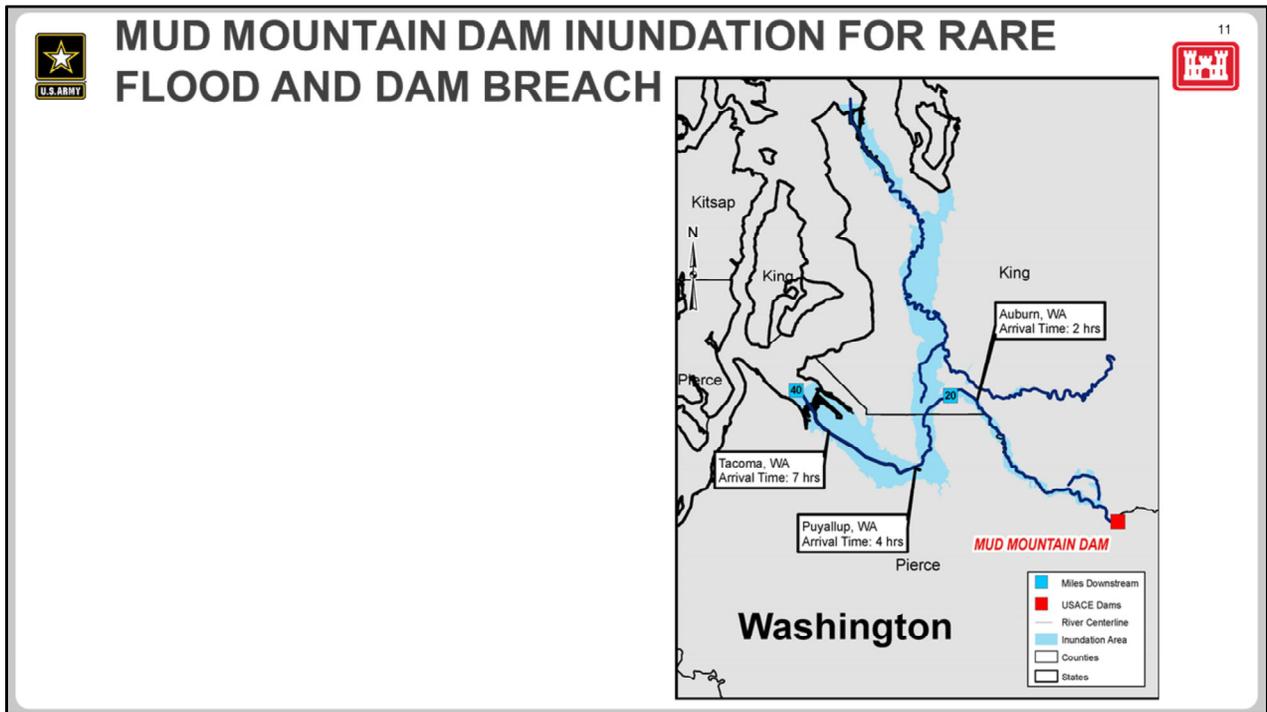
This map shows that a failure of Mud Mountain dam during an extreme flood event has the potential for flooding in both Pierce and King Counties.

Based upon the most recent risk assessment of Mud Mountain Dam in 2018, USACE considers Mud Mountain Dam to be a moderate risk dam among its more than 700 dams because the consequences associated with a dam failure are very high. Dam safety risk is primarily driven by the potential for embankment erosion from Lower Cascade Creek during a rare flood event and subsequent overtopping and failure of the dam.

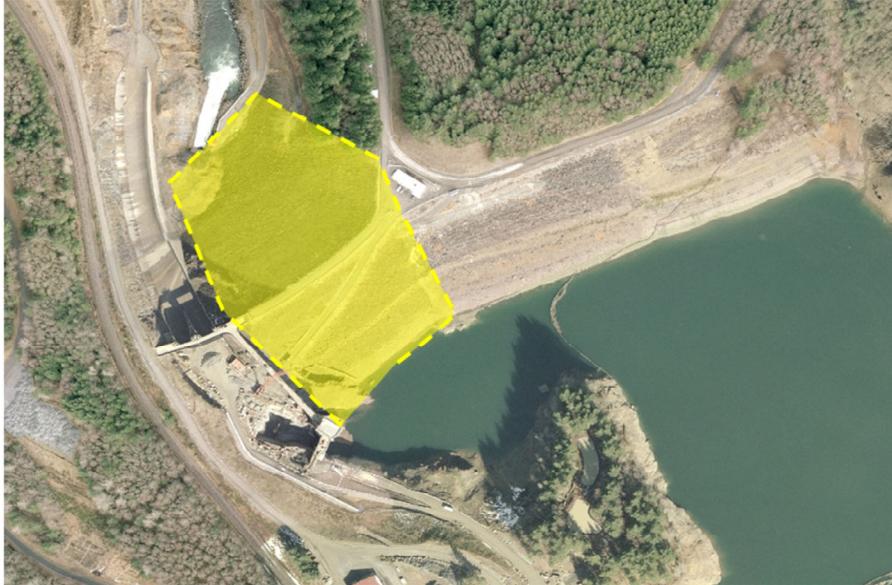
HOWARD A. HANSON DAM - FEATURES

Howard A Hanson Dam is an earth embankment dam with:

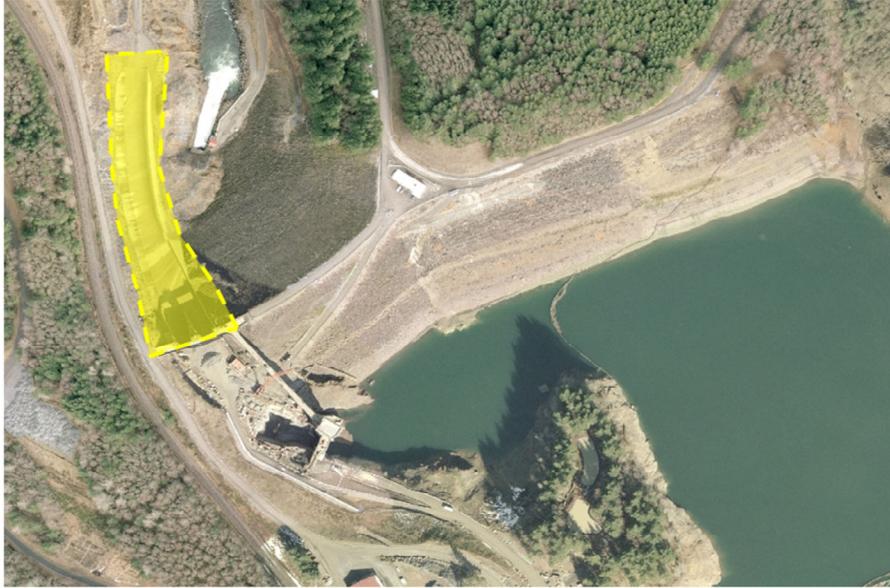
HOWARD A. HANSON DAM - FEATURES

A flood control spillway

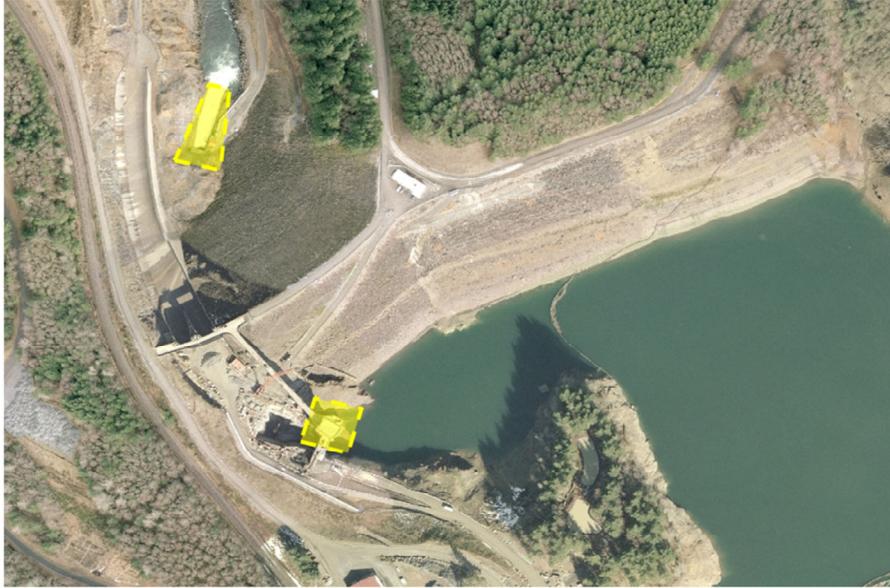
HOWARD A. HANSON DAM - FEATURES

And an intake tower with connecting tunnel in bedrock to the outlet works and stilling basin.

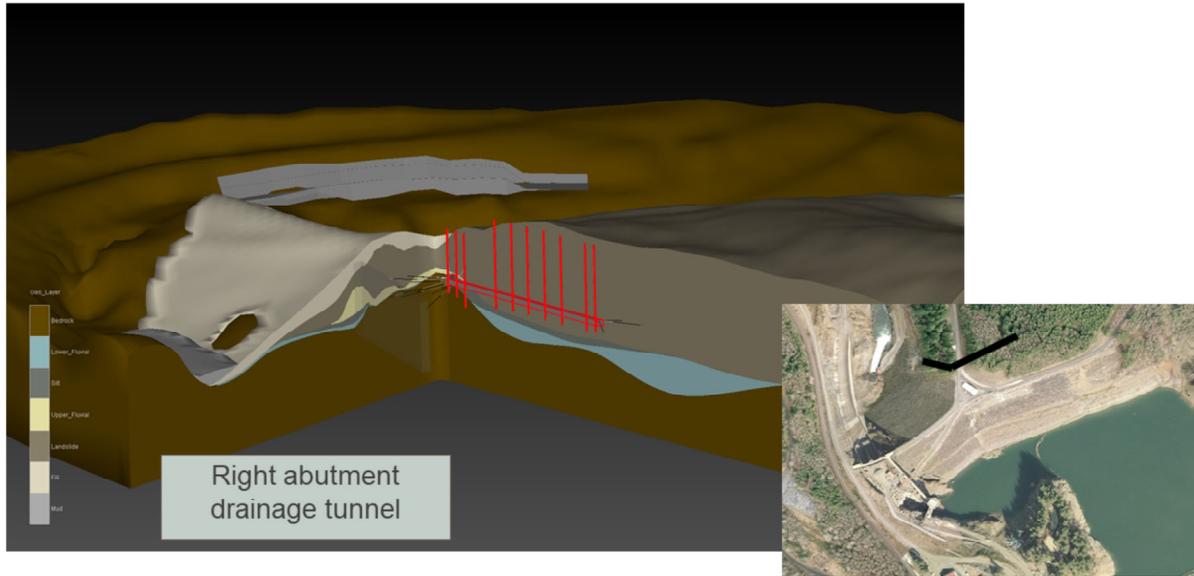
HOWARD A. HANSON DAM - IMPROVEMENTS

In 1965, the first flood pool was held above an elevation of 1160.0 feet. At a reservoir elevation of 1161.8 feet, leakage appeared on the downstream right abutment at an elevation of 1134.0 feet. An estimated flow of 80 to 100 gpm was observed when the pool was at 1140.0 feet and dropping. The leakage saturated the loose slope wash on the steep hillside and caused local sloughing of the surface material. The water flow caused further minor erosion of underlying compact till. An inspection found the emergence to be coming from the slide material at the contact with the underlying glacial till. The seepage was clear, and the till did not appear to be eroding appreciably. Other springs were intermittently spaced and seepage was observed flowing from the bank at elevations as high as 1120.0 feet. There was no evidence of water discoloration or surface erosion. A crib wall with drainage was designed and installed to provide slope stability. The need for increased seepage control and downstream stability of the right abutment led to the installation of the drainage tunnel in 1969, with a gravel floor drain and vertical drains. Additional horizontal drains were installed downstream of the tunnel, and piezometers were installed within the right abutment to stabilize and monitor the right abutment.

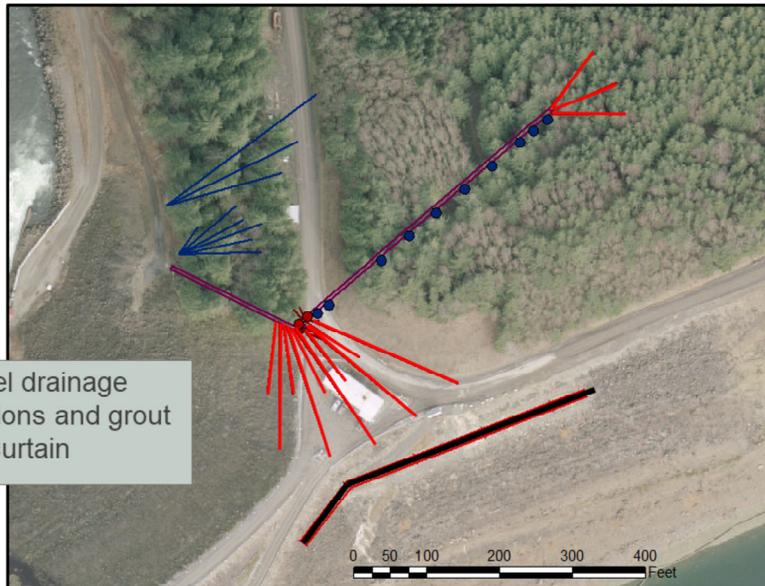
Tunnel drainage modifications and grout curtain

Negative performance observed during the 2009 flood pool of record led to modifications of the right abutment drainage tunnel. Vertical drain 25, a source of turbid water during the record pool event, was constructed within a silty material with blade cut slotted steel casing and no filter material between the slots and the surrounding formation. Drain 25 was replaced by two new nearby vertical drains with properly designed filter material and wire wrapped screens. Thirteen new horizontal drains with properly graded filters and screens were installed from within the tunnel (shown as red lines). Three of these drains were installed from the terminus of the tunnel, and ten were installed from the area where the tunnel bends and turbidity has been noted in the past.

A grout curtain was installed on the upstream face of the dam to intercept and impede the flow of water through the abutment and the contact of the embankment with the abutment. The combination of these features were very effective in controlling seepage through this region.

These were considered temporary measures to deal with right abutment seepage until studies and designs to install a permanent solution were completed.

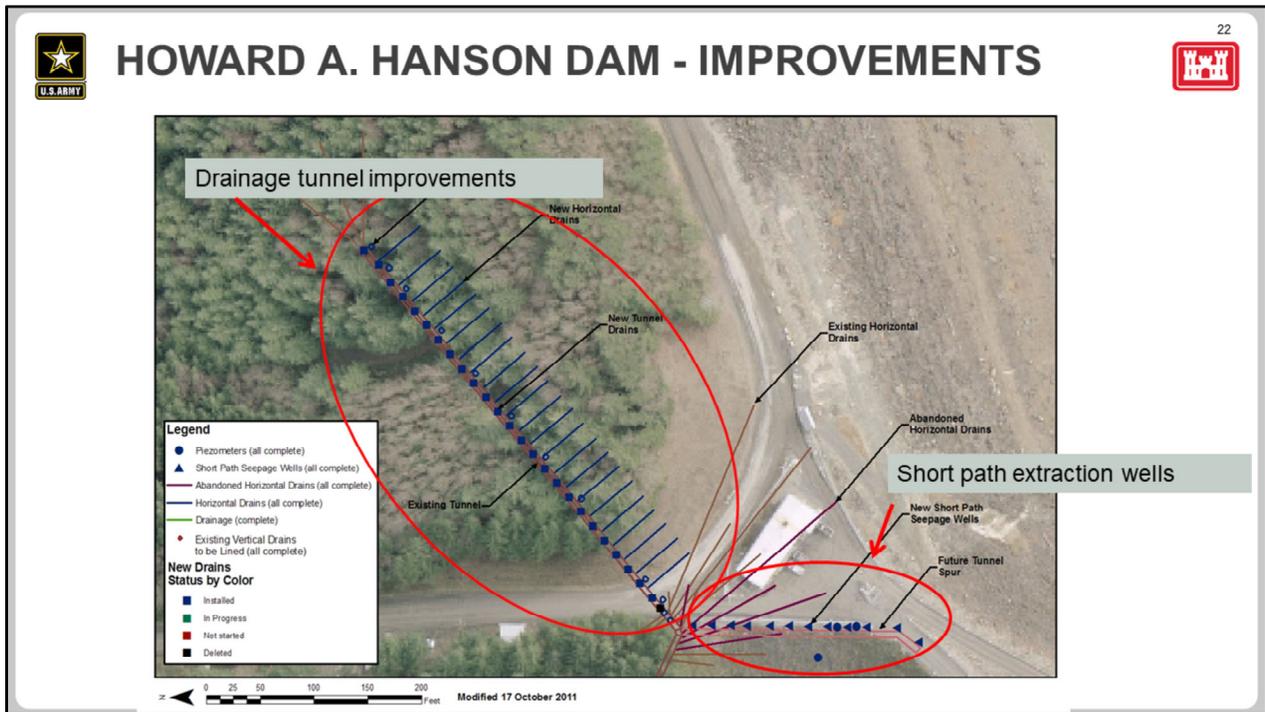
HOWARD A. HANSON DAM - IMPROVEMENTS

The final repair completed in 2012 consisted of installing new vertical drains in the existing tunnel, relining the existing vertical drains with properly filtered drains, installing new horizontal drains on the upstream side of the tunnel, and installing a series of extraction wells to remove seepage water that might penetrate through the short path seepage area during an extreme flood event and initiate internal erosion of the abutment/embankment contact.

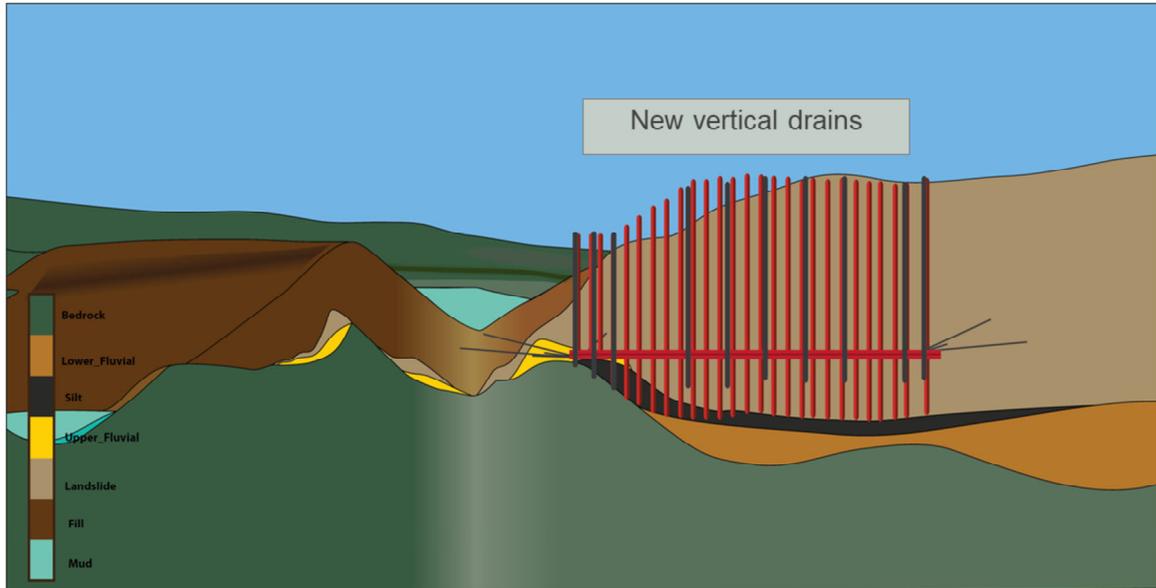
HOWARD A. HANSON DAM - IMPROVEMENTS

New vertical drains shown in red. Note that new drains fully penetrate the landslide material that forms the upper aquifer and is responsible for seepage of concern.

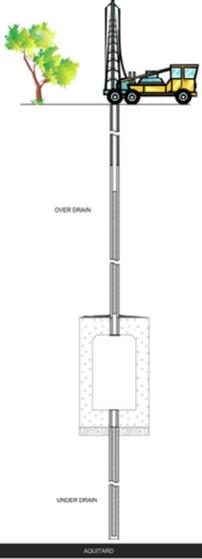
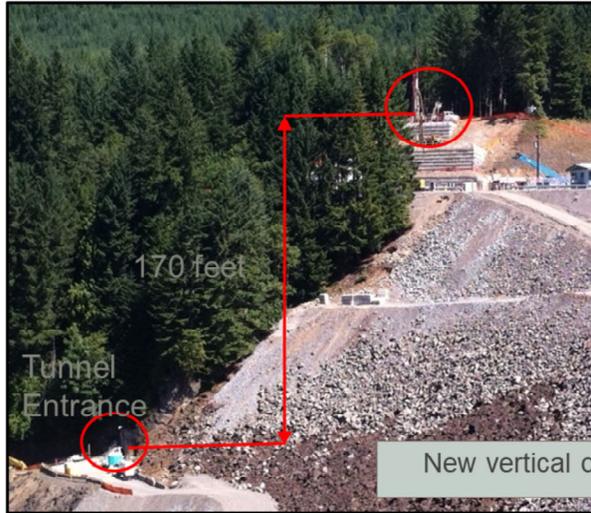
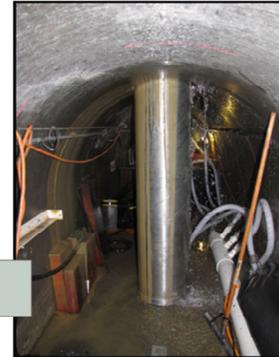
New vertical drains

It was challenging to target a tunnel so far underground.

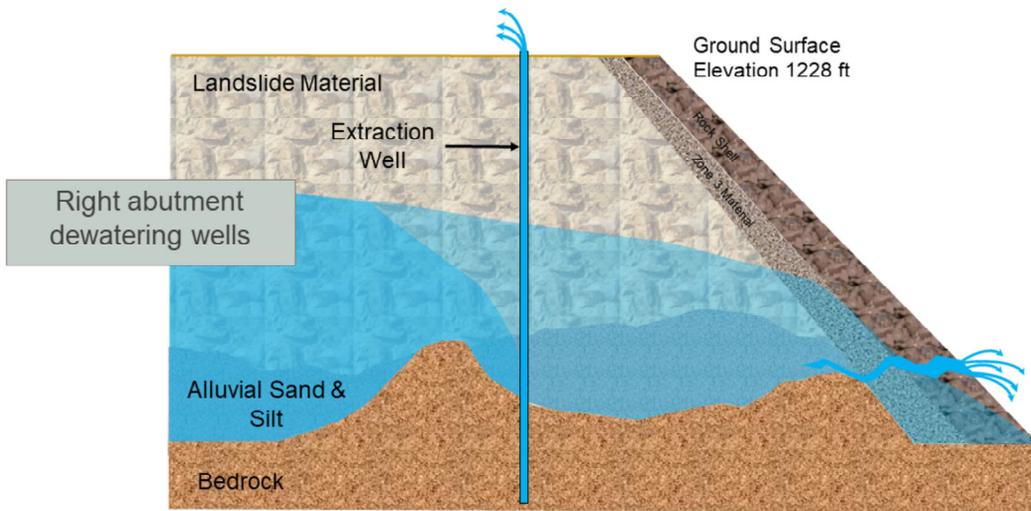
HOWARD A. HANSON DAM - IMPROVEMENTS

Animation shows how seepage through the abutment materials could create saturated conditions from the pool to the downstream contact with the embankment. Because the embankment materials are filter incompatible with the rock shell and the abutment, this could lead to internal erosion. The extraction wells are designed to intercept this water and prevent it from reaching the critical contact between the abutment and the embankment materials, thus eliminating the pathway for internal erosion.

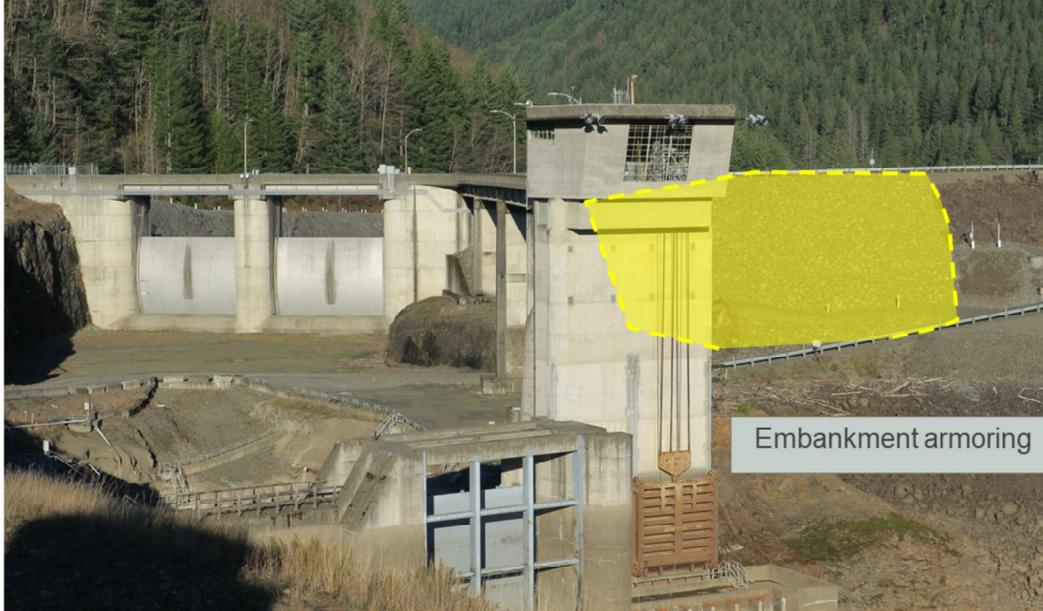
HOWARD A. HANSON DAM - IMPROVEMENTS

A portion of the upstream embankment was re-armored to prevent erosion during a spillway use event. The old armor stone had degraded with time until it was broken down into sizes that were too small to remain in place given the model generated velocities expected across the embankment face during a spillway use event.

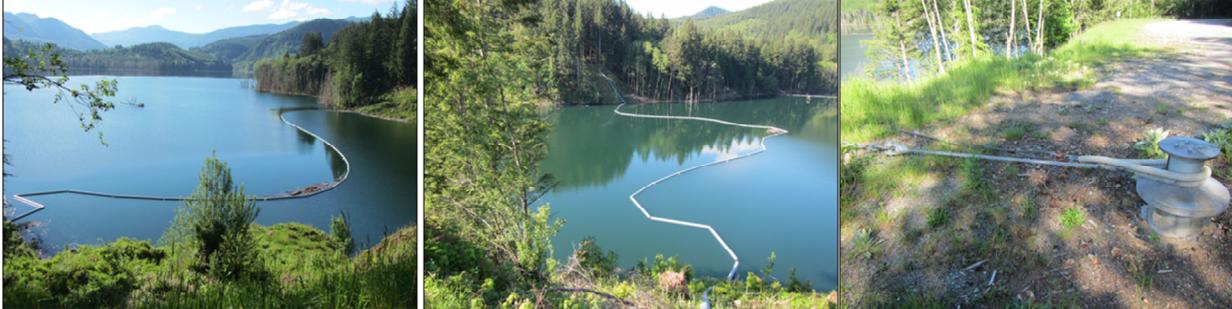
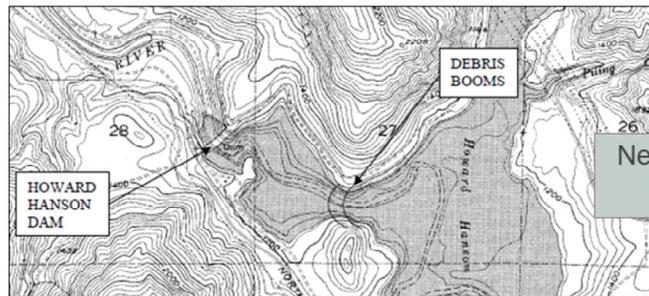
New log booms for woody debris management

The spillway gate openings are relatively narrow in comparison to the length of woody debris that can accumulate in the reservoir during a major flood. If the spillway were to become obstructed, overtopping and breach of the dam could occur. A new log boom system was installed to ensure that floating debris are captured upstream of the spillway.

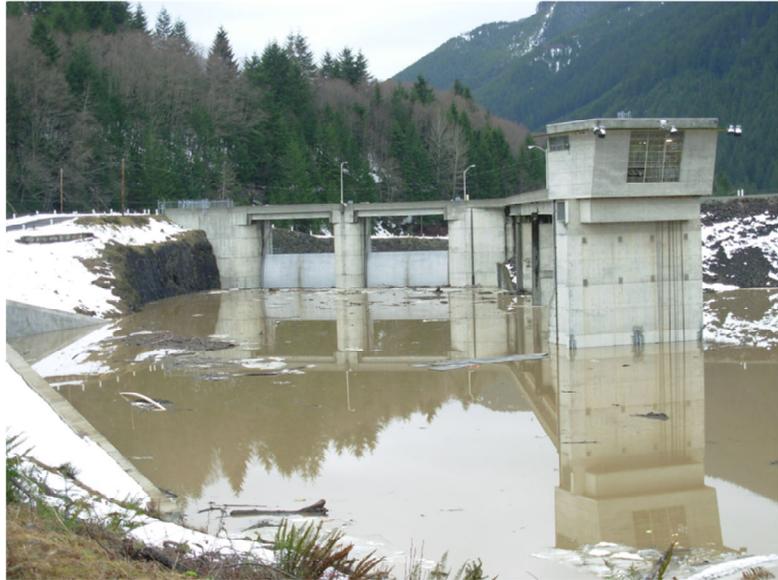
Pool of Record
– January 2009
– Elevation 1188.8 feet
NGVD 29
– 17.2 feet below top of
spillway gates

The dam has never experienced its full pool and the spillway has never been used to pass flow. Howard Hanson Dam provides flood risk management benefits to over \$25 billion in infrastructure located in the lower Green River valley, which includes the cities of Kent, Auburn, Renton and Tukwila.

It is operated for multiple purposes in the winter, spring, summer, and fall. Flows are regulated manually by adjusting the tower gate controls at the dam (located at the base of outlet tower) with direction from the NWS Water Management Section. During winter months (October through February), when the flood threat is at a maximum, the reservoir is kept essentially empty. Normal river flow at this time is passed through the outlet tunnel in the dam's left abutment. When the river flow reaches flood stage, control gates in the outlet tunnel are regulated to manage river flow at the control point at Auburn, Washington, to 12,000 cubic feet per second (cfs) or less, as feasible. The normal historical summer conservation pool was initially set at an elevation of 1141.0 feet. With the implementation of the Section 1135 Fish and Wildlife Restoration Project in 1996, the conservation pool was raised

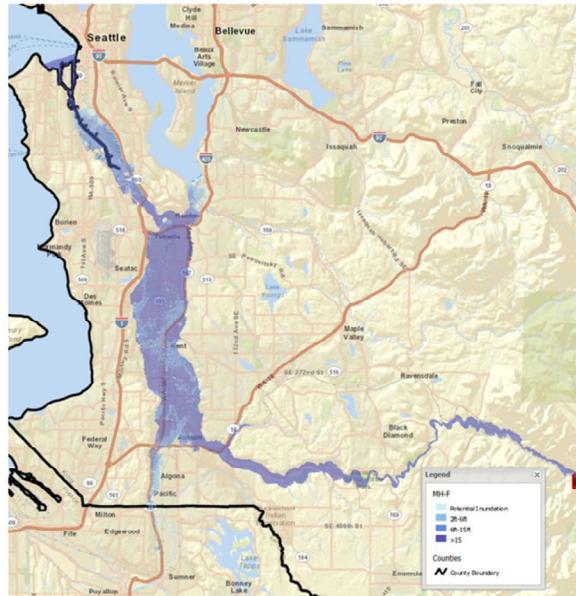
HOWARD A. HANSON DAM INUNDATION FOR RARE FLOOD AND DAM BREACH

Based upon the most recent risk assessment in 2014, USACE considers this dam to be a low risk dam among its more than 700 dams because of the recent repairs completed to reduce risk associated with embankment abutment seepage and piping, embankment erosion during spillway use, and spillway debris blockage.

Note that the flooding event shown in this overview in pink combines a dam failure with the Probable Maximum Flood. This is a worst case event.

A breach of the dam under these conditions has the potential to cause minor flooding in Pierce County, also due to relatively low watershed divide between the White and Green Rivers.
